Intel® Pentium® M Processor on 90nm Process with 2-MB L2 Cache

Specification Update

May 2004

Document Number: 302209-001

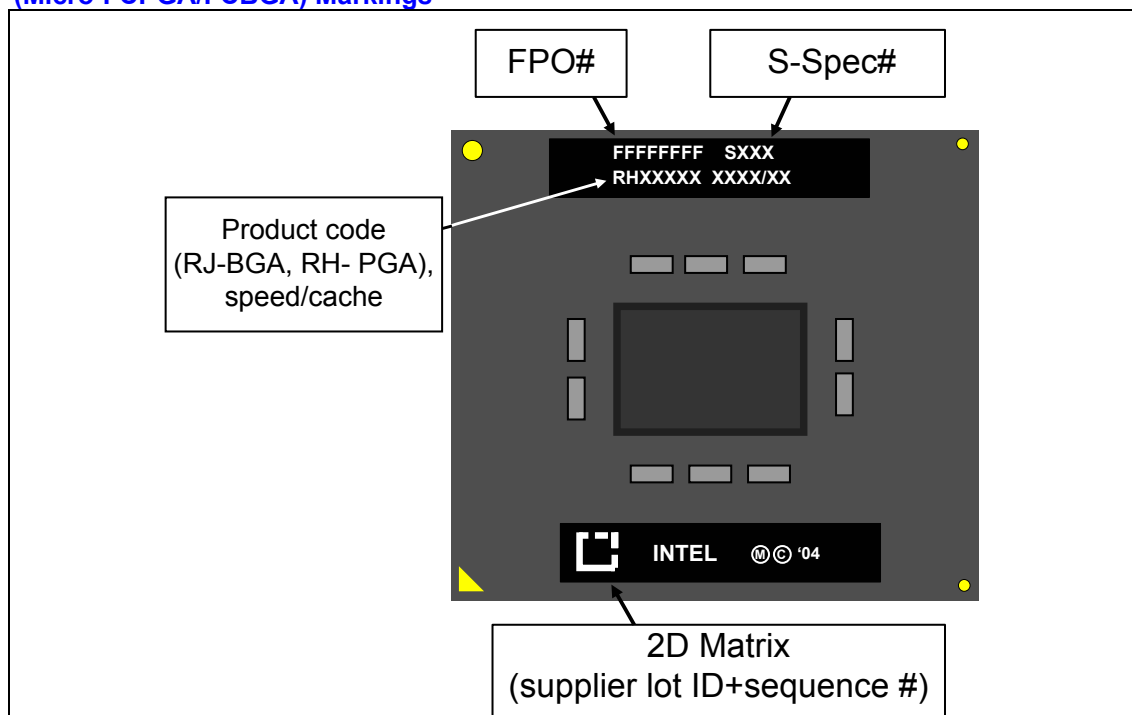
Figure 1. Intel® Pentium® M Processor on 90nm Process with 2-MB L2 Cache (Micro-FCPGA/FCBGA) Markings
